Slab meshing issue

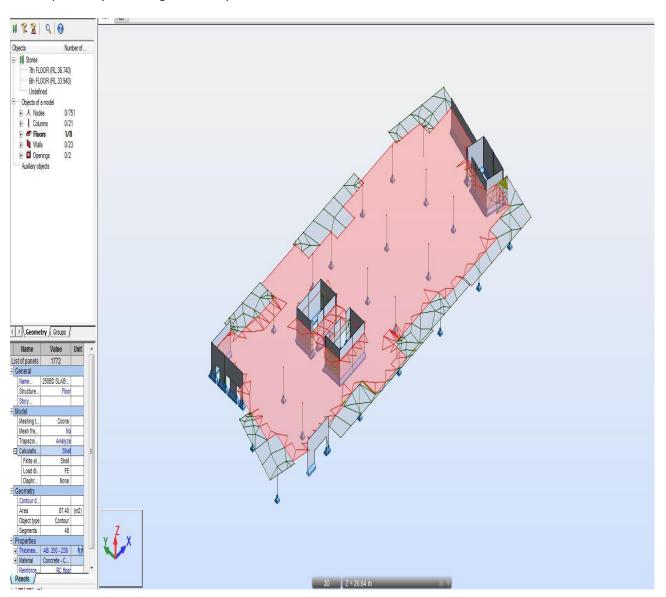
As can be seen in the attached sketch, the slab is defined as a shell with load distribution set to FE.

When I try to run the analysis, I can see that the main floor slab is not getting meshed at all.

I have verified that the top points of the columns have the same 'z' co-ordinates as the floor level, i.e. I am fairly confident that the top of the column is connecting to the slab. In the Revit model too, there are no offsets provided at the top and bottom of the column. Further it is seen that there are no reactions seen at the bottom of the column, suggesting that the slab is not connecting to the column.
