View - [-]Deflection (mm)

LOAD CASE 103: SLS 1/3 LL

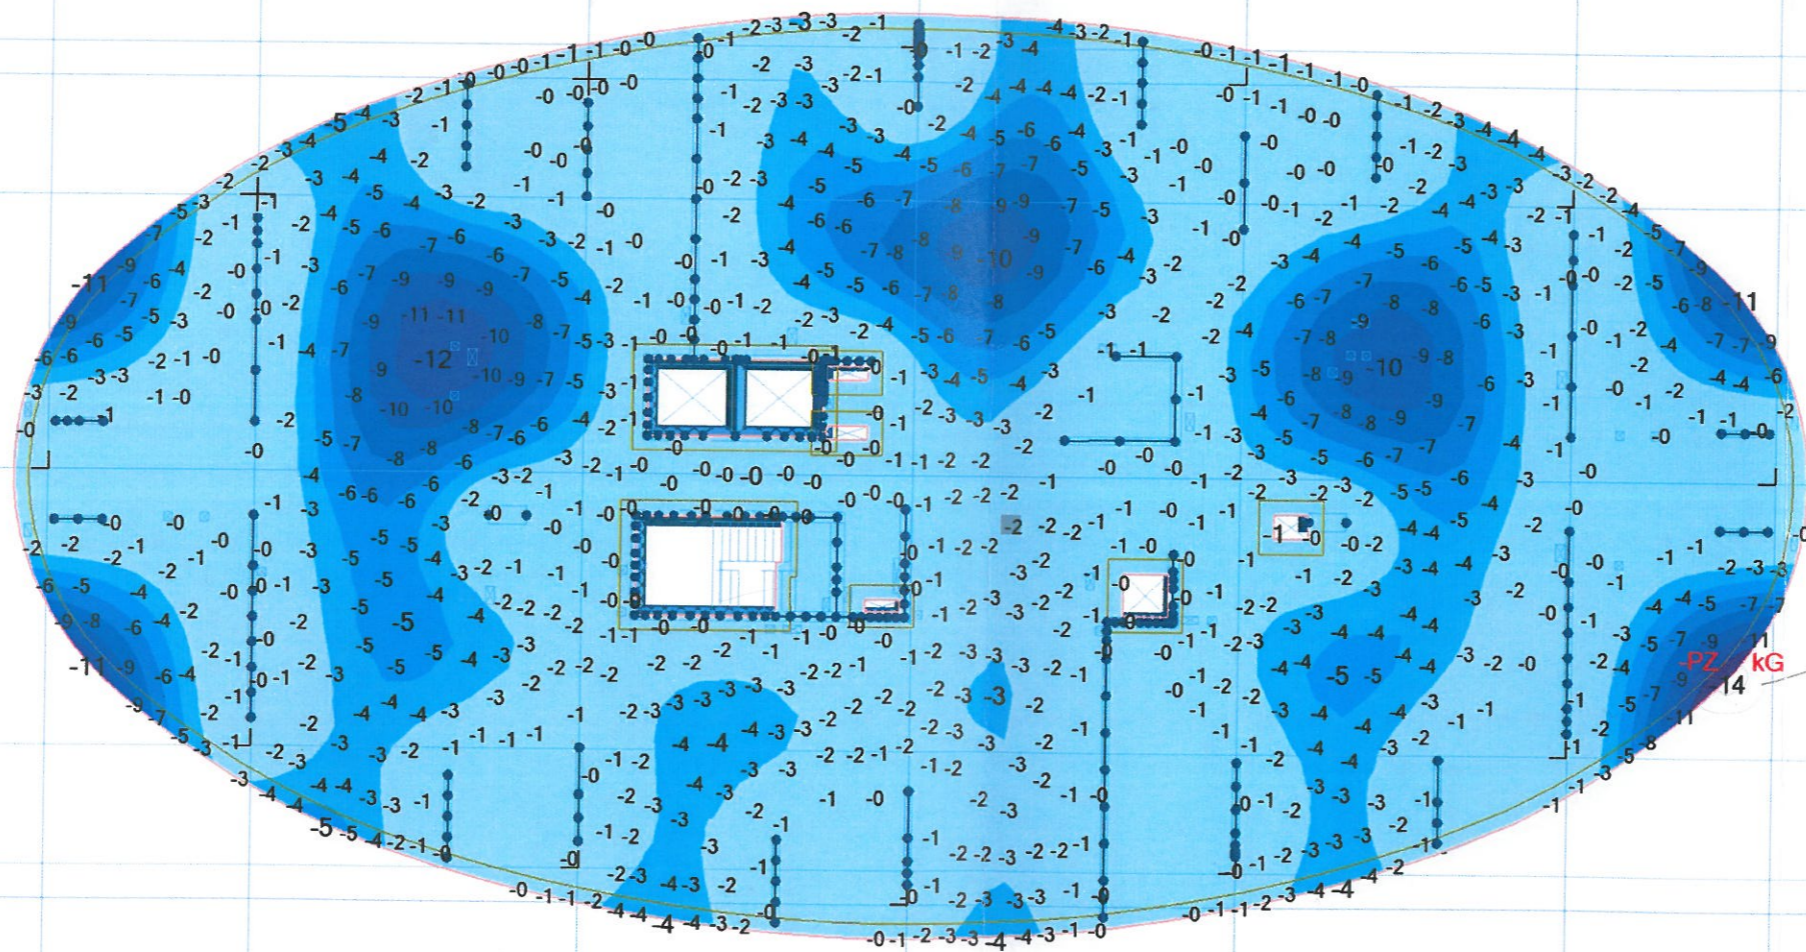
CRACKED.

S/W, S.I.D, 1/3 LL, Creep.

Total S LLS.
20 mm (4mm)
