ADDED RET ARRAY OF HOLES FOR FASTENERS. ASS'Y BLOWS UP. ALL PARTS WERE FULLY CONSTRAINED.

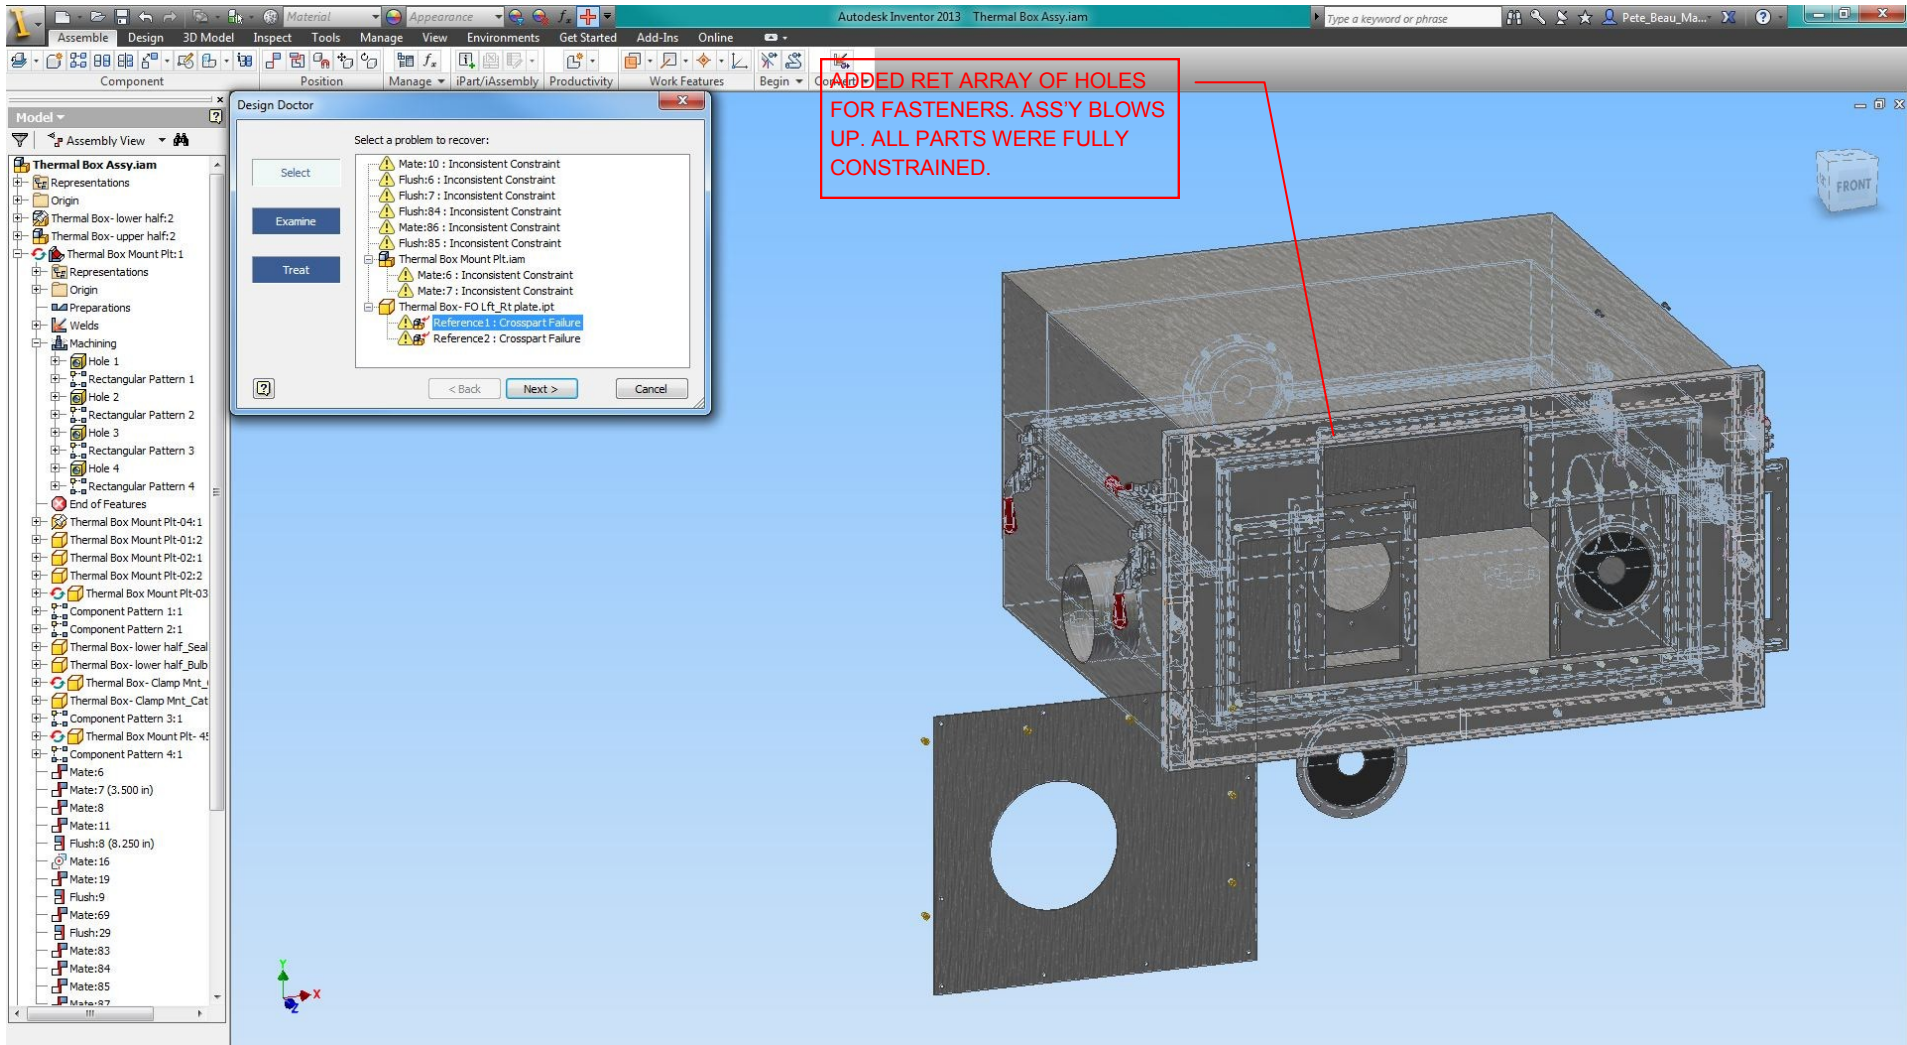
- Mate:10 : Inconsistent Constraint
- Flush:6 : Inconsistent Constraint
- Flush:7 : Inconsistent Constraint
- Flush:84 : Inconsistent Constraint
- Mate:86 : Inconsistent Constraint
- Flush:85 : Inconsistent Constraint
- Mate:6 : Inconsistent Constraint
- Mate:7 : Inconsistent Constraint
- Thermal Box Mount PIt.iam
 - Thermal Box - FO LFR_Rt plate.ipt
 - Reference 1 : Crosspart Failure
 - Reference 2 : Crosspart Failure
